Nutrient Reduction Project

Silver Lake Stream Improvement Report

October 16, 2024

Silver Lake Water Quality Committee

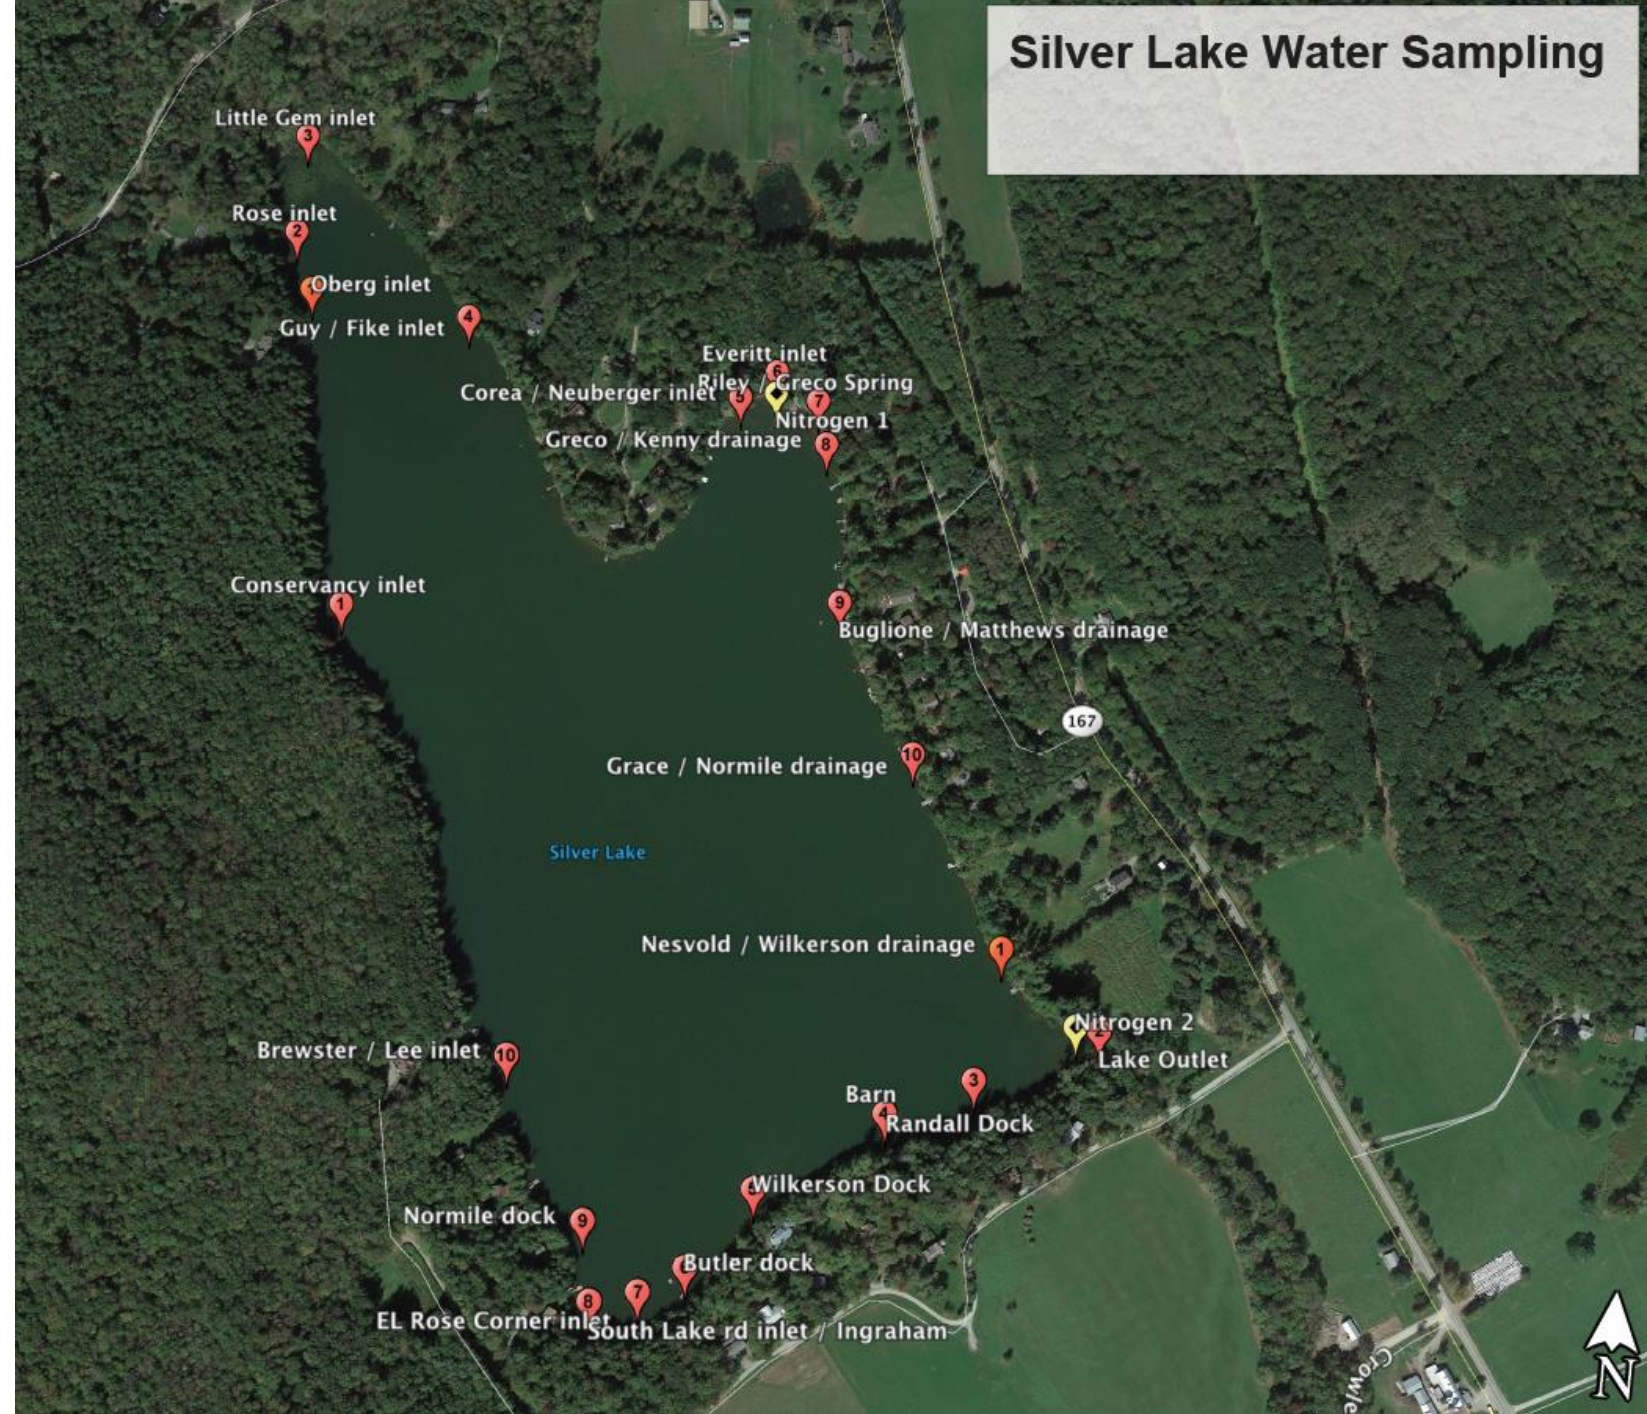
Testing sites

- Pre-project –
27 lake / input sites
- Three inlet streams
With repeatedly high
TP readings;
#3, off Quinn road
#6, off farm field/pond
#17, off farm field

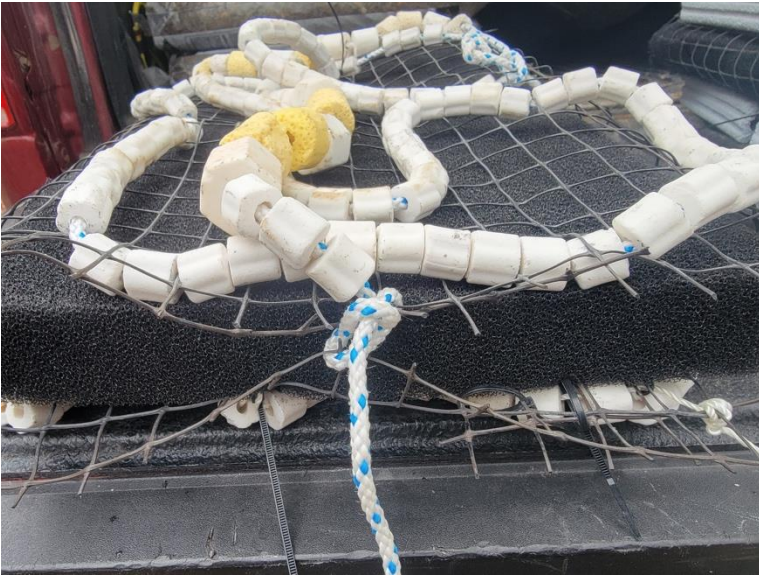
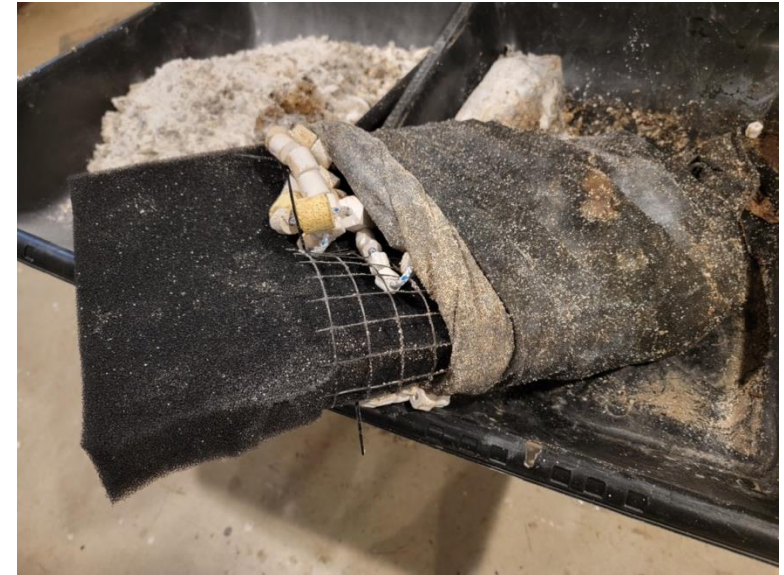
Physical Modifications (V2 prototypes) to improve water penetration

- Perforated tray to lift bag slightly off stream bottom
- Allow better water penetration into center of material
 - Central hollow core or
 - Central filter spacer
- Periodically flip bags
- Ceramic moveable spacers within material to break up clumping

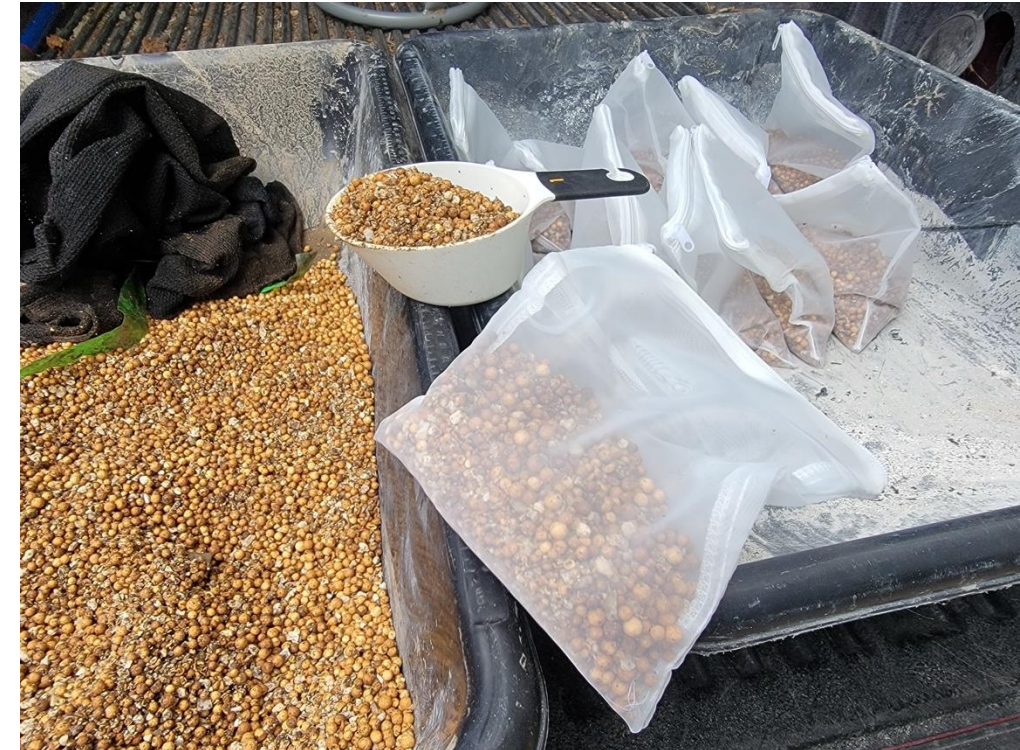
Cooperation with SePRO – 2024 data/product sharing

- EutroSORB F (V3). - prototype product partially based on our data
 - (Pellets with surrounding powdery material)
 - No clumping EutroSORB anywhere
 - Larger Bag Fabric pores allowed more penetration
 - Volume inside bag - wet and more uniformly discolored.
- V3 Observations – Improvements
 - Better water penetration
 - No clumping
 - Filter spacer in center of V3 material - effective and non-clogging
 - Similar performance of V3 in 1 month to V2 in 6 months

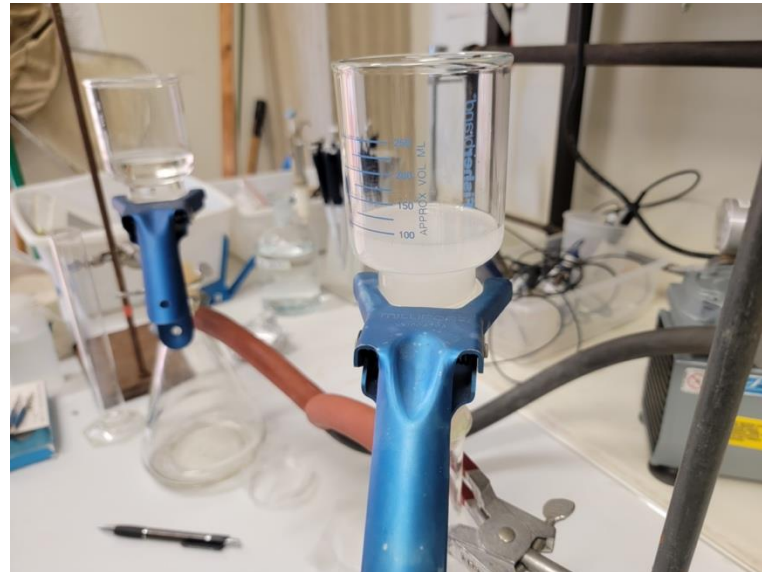
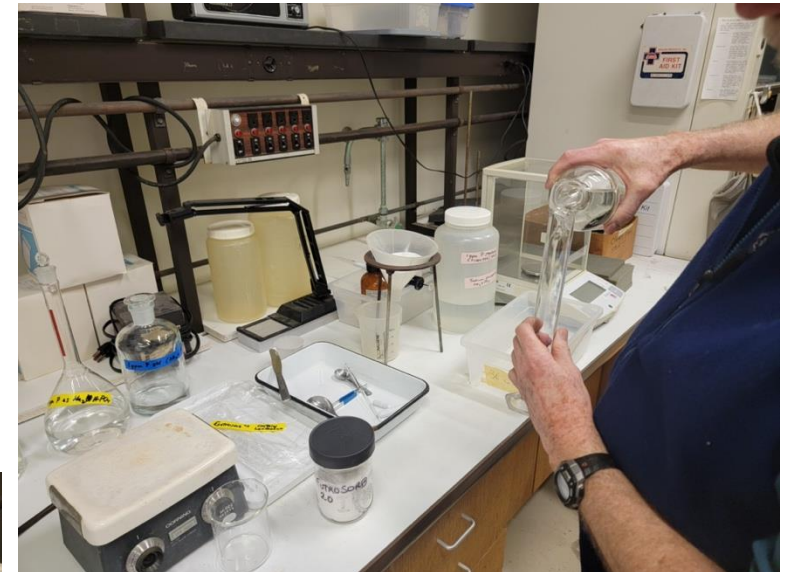
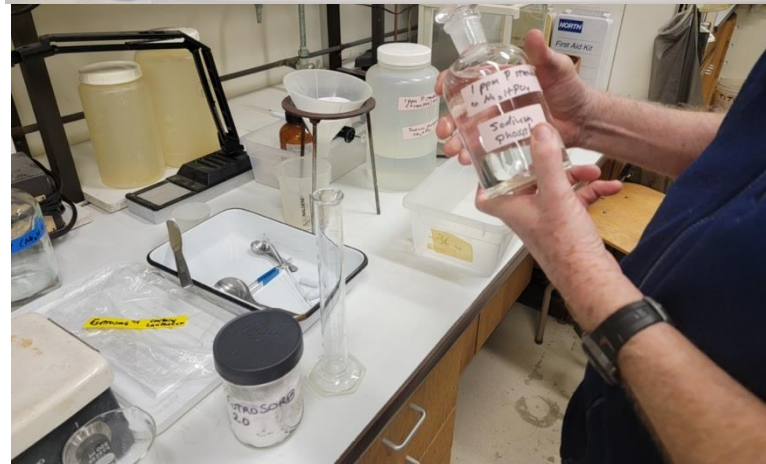
EutroSORB BU Lab Verification Process

- Goal – prepare a filtrate to show how much Phosphorus was adsorbed by a used sample of EutroSORB

John Titus, Prof. Emer.
The filtrate solution was sent to the UFI lab for Total Phosphorus analysis. That TP was not adsorbed as it passed through the EutroSORB Sample at the BU lab.
